# Manhole Inspection Summary

Manhole # S25EE1042MH

Insp Date: **1/24/07 1:47 PM**

**Location** Address: **1015 RECTORY LN**

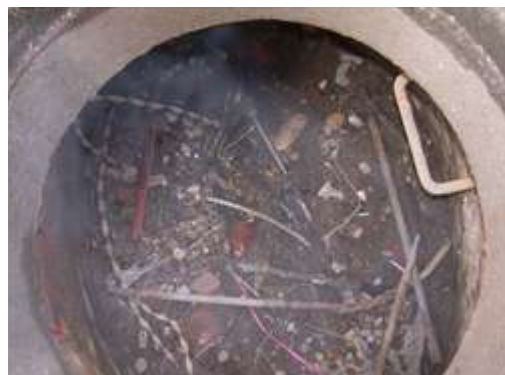
Top View

Channel debris.

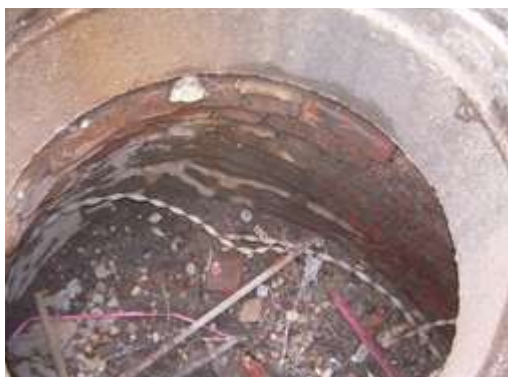
Defect

Frame leaks. Adjustment deterioration and infiltration. Corbel and Barrel infiltration.

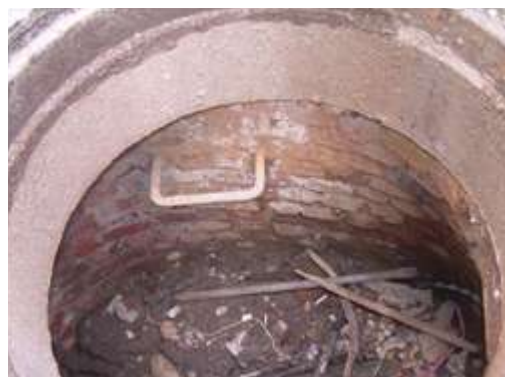
Defect

Frame leaks. Adjustment deterioration and infiltration. Barrel infiltration.

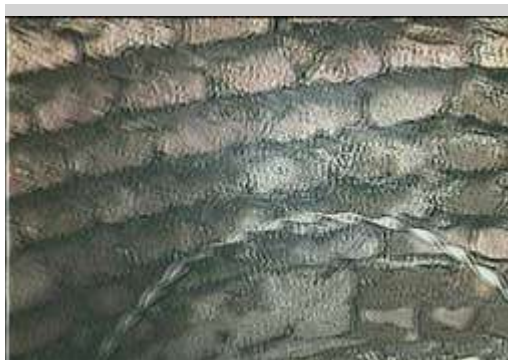
Defect

Barrel deterioration and infiltration.

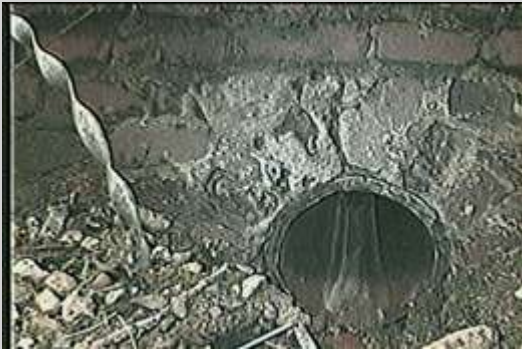
8 in. Circular Gravity Sewer  
Pipe Out @ 12 O'Clock

Infiltration: **Evidence** Pipe Seal Cond: **Unknown**
